CITY LAKE DAM

CASS COUNTY, MISSOURI

PHASE 1 INSPECTION REPORT NATIONAL DAM SAFETY INSPECTION

Name of Dam	City Lake Dam
State Located	Missouri
County Located	Cass County
Stream	Town Creek
Date of Inspection	12 April 1979

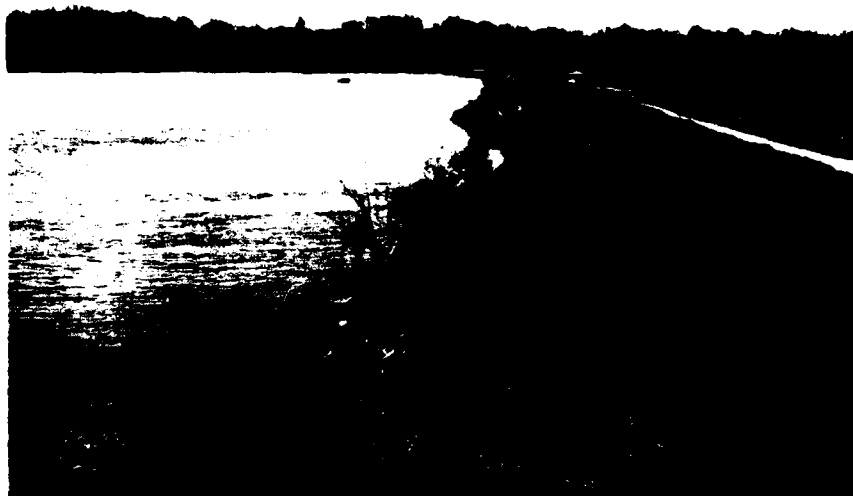
PHOTO 1: UPSTREAM FACE OF DAM LOOKING SOUTH

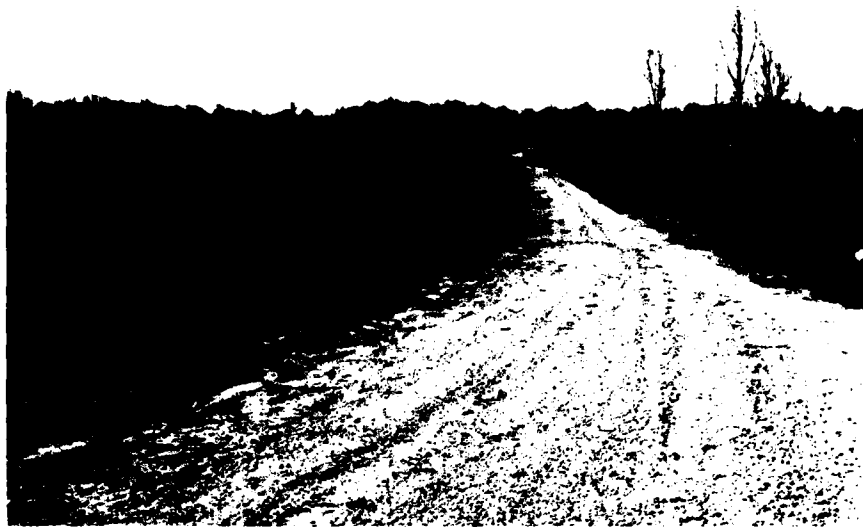
PHOTO 3: BACK SLOPE OF DAM LOOKING SOUTH

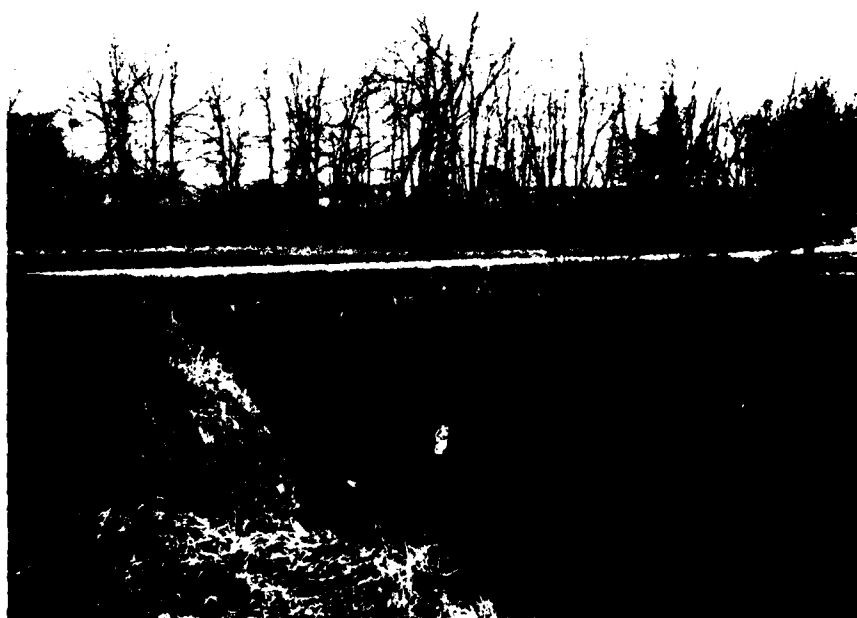
of slope protection and to the erodable nature of the embankment materials, overtopping for a sustained period of time could result in failure of the dam. Also overflow of the right abutment is likely to cause excessive erosion of the dam which could result in failure.

PHOTO 8: LOW AREA AT RIGHT ABUTMENT

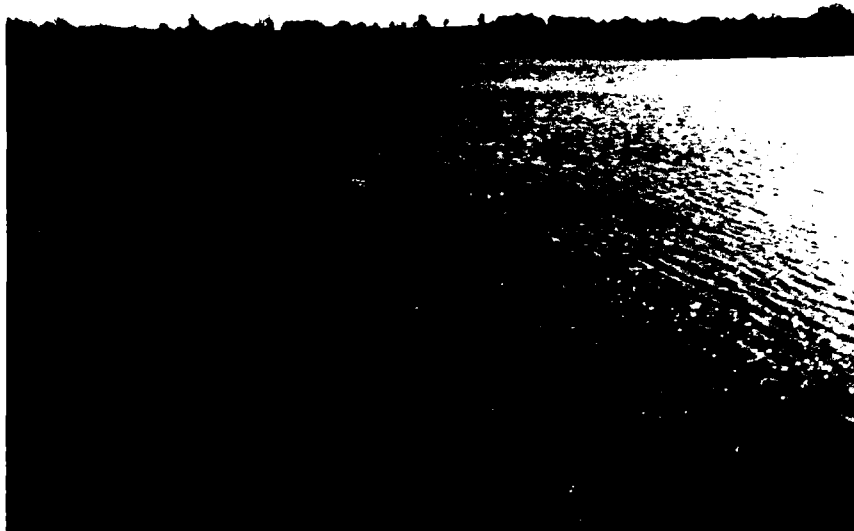
(2) No facilities are available which could serve to draw down the pool. A concrete intake structure is visible in the lake. The Black & Veatch 1947 drawing shows an 8-inch water line connected to this structure. This line was not observed during the inspection.

PHOTO 9: WATER SUPPLY INTAKE STRUCTURE

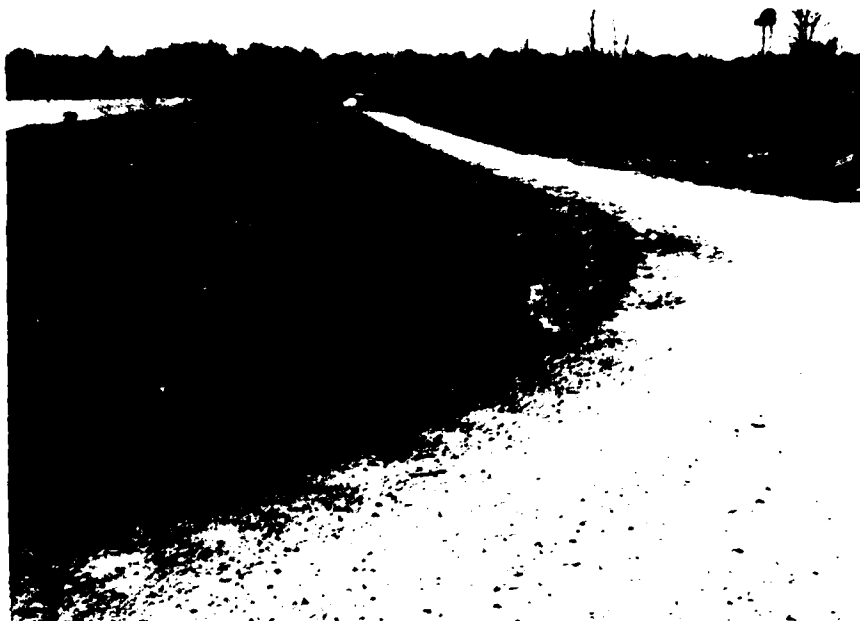
(2) The drainage ditch along the toe of the dam has caused erosion of the embankment material which has resulted in sloughing and sliding of the back slope of the dam. The lack of slope protection on the back slope will result in continued erosion of the embankment material.

PHOTO 11: DRAINAGE DITCH AT TOE OF SLOPE RIGHT END OF DAM

(3) Slope protection, such as good stand of grasses, should be developed on the back face of the embankment. The roadway and drainage ditch around the north end of the dam should be realigned to allow for a flatter back slope on the dam where sloughing has occurred. The erosion and sloughing should be repaired.

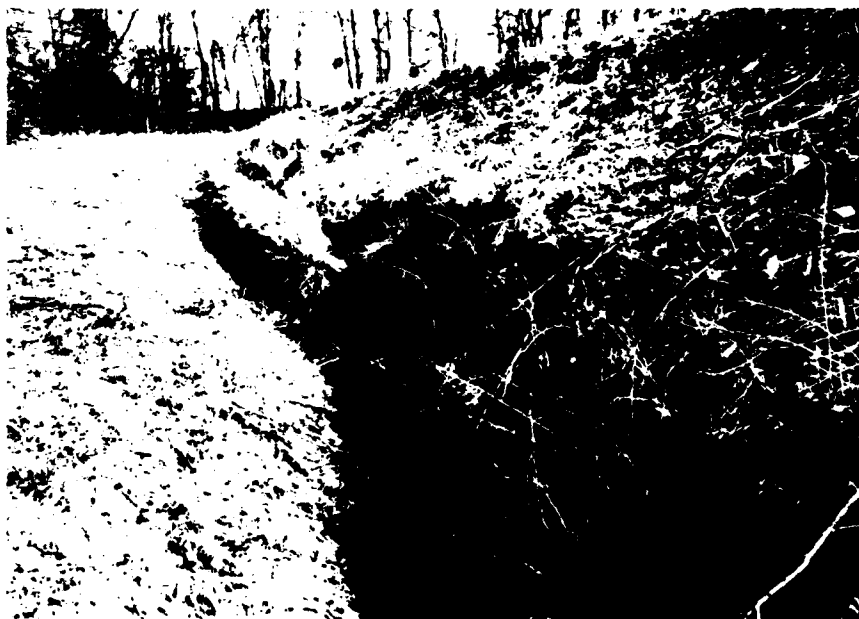
PHOTO 12: SLOUGHING OF EMBANKMENT AT DRAINAGE DITCH RIGHT END
